Corrosion protection and the cost of failure

Lasse Isaksen^a

Case study: FPSO conversion project with design life of 13 years

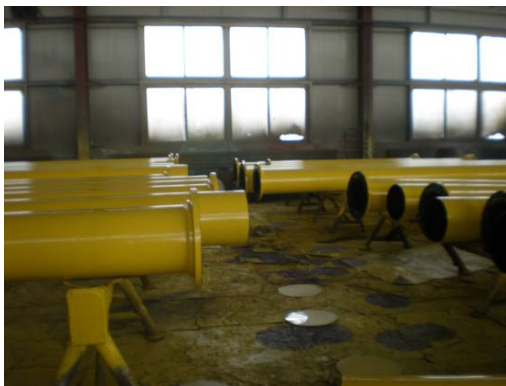
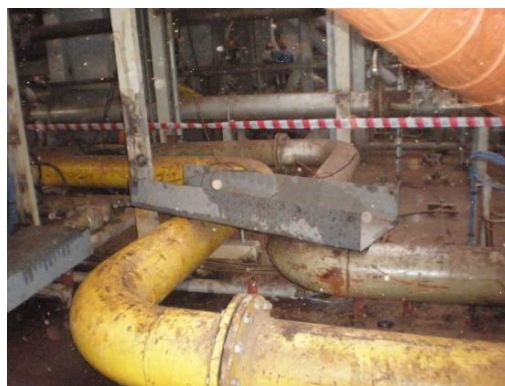
The survey revealed that there was significant damage on the unit due to coating failures, much more than could be expected. The coating specification selected should not have caused this. However when going back looking in documentation at constructing phase, it became clear the breakdown was caused by errors in surface preparation and application during the construction phase. Many of the failures was caused by cutting and hot works after initial painting was done and thus damaging the coating. Pipe spools and process modules produced at other sites looked ok but were exposed to mechanical damage during transport and installation.

Figure.3: Example showing that blasting and painting of piping at workshop was of good quality. However paint work experienced a lot of mechanical damage, during transport and installation in addition to dirt on site.

The premature breakdown of the coating systems will need to be corrected offshore at the field for a considerable expense to the operator.
