Trabalho apresentado durante o INTERCORR 2010, em Fortaleza/CE no mês de maio de 2010.

## **The effect of zinc addition in stress corrosion cracking initiation in nickel alloy 600 in simulated PWR primary water**

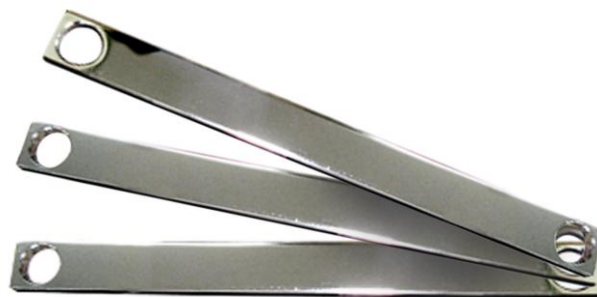
Figure 3. Inconel 600 plates polished up to 1  $\mu\text{m}$ .

The Inconel 600 plates were grinded with SiC paper (grit sizes 180; 280; 320; 400; 500; 600; 1200; 2000) and polished with diamond paste (6  $\mu\text{m}$ ; 3  $\mu\text{m}$ ; 1  $\mu\text{m}$ ). Figure 3 shows the final surface of the plates.

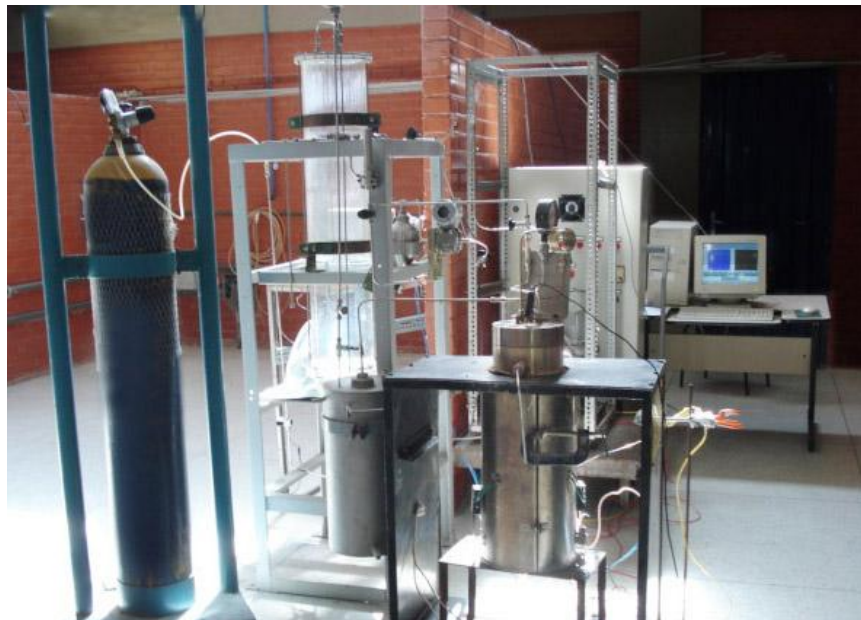
Figure 6. Facility for SCC tests.

Figure 6 shows the facility used in this work. It is used to do accelerated SCC tests in laboratory scale. It comprises an autoclave, instruments to measure temperature and pressure and a water tank where the desired water chemical composition can be adjusted.
