Trabalho apresentado durante o INTERCORR 2012, em Salvador/BA no mês de maio de 2012.

Understanding biocorrosion in practical cases of different industrial systems

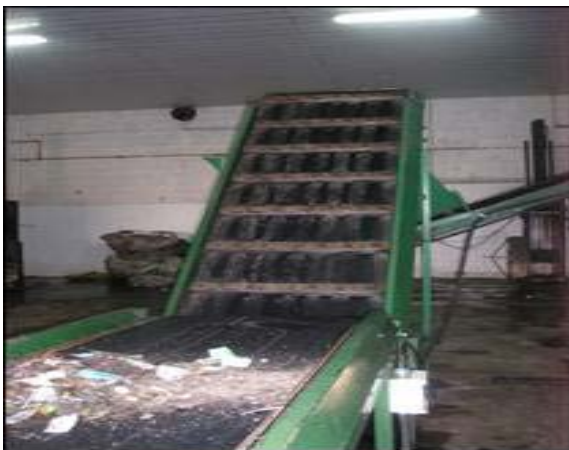
Figure 1 - USW treatment plant

In the USW treatment plant the results obtained by the SRB countings of levels reaching to 1×10^6 mo/cm², suggest that both the risk area (steel conveyor belt, Fig.1) and the area sampled can show an important potential of MIC (16, 17). It is important to highlight the presence of acid producing bacteria that would be involved in the MIC processes. The acidification produced by these bacteria that was verified at the laboratory (decrease of more than two units of pH) can have a synergic effect on the corrosion of inorganic origin and accelerate the deterioration processes in the structures of the USW treatment plant. The pH measures of the samples of the 1 and 2 emulsions allow confirming a pH decrease of about 5 in two units compared with the pH of the original emulsion (10, 11). This decrease could be given by the presence of acid metabolites coming from the bacterial and fungal activity broking the steel passivity and causing biocorrosion emergence.

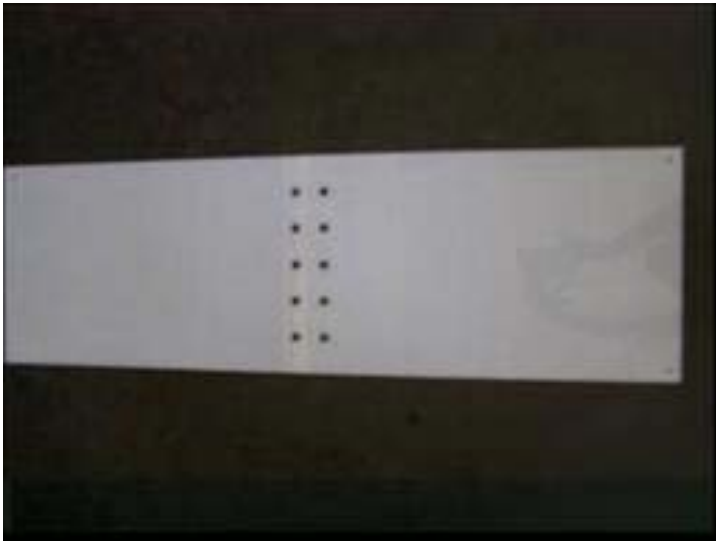
Figure 2 - Sampler

In figure 7 it can be observed the attack by pitting on a SAE 1010 steel coupon coming from the sampler placed in the USW treatment plant (Figure 2).

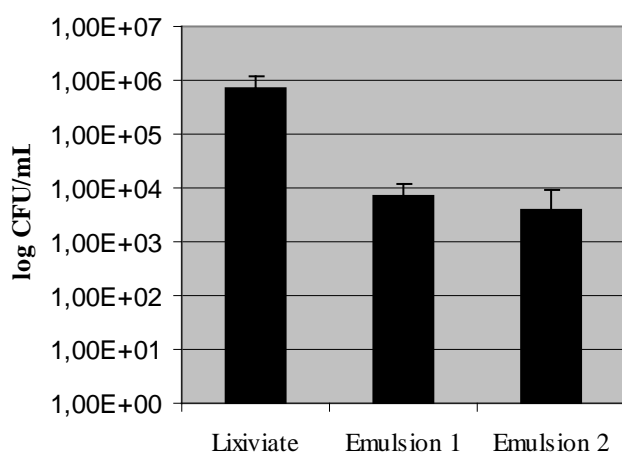
Figure 3 - Total heterotrophic mesophilic bacteria

In Table 1 and Figure 3 it can be seen the count obtained of different samples.

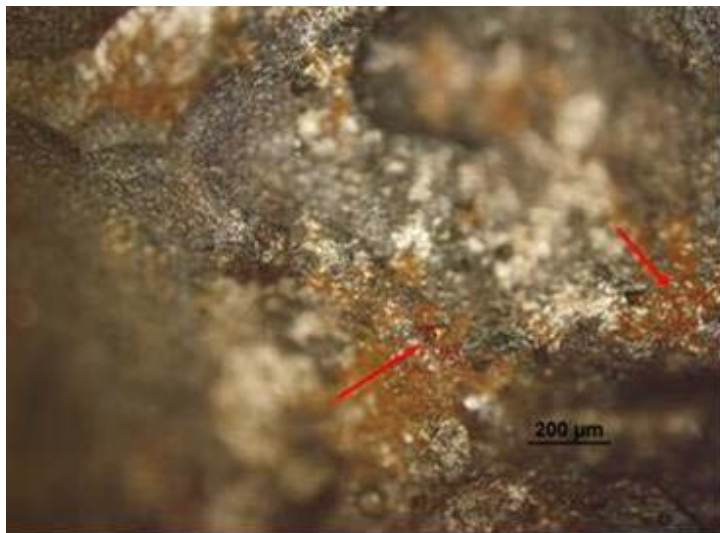
Figure 5 shows the sample from the filter after removing sediments, orange or chestnut-brown colored zones and a general attack can be observed. In figure 6 the zone attacked by pitting can be observed.

Figure 5 - Photograph of the filter. Orange colored zones (indicated) and brilliant streaks can be observed (10X)

The surface studies with optical microscopy on the filters allow to observe brilliant zones and the formation of ocher-orange-colored tubercles together with pits irregularly distributed on the surface (Figures 5 and 6). This was corroborated by the growth of viable microorganisms indicated in table 1. These microorganisms are involved in the MIC processes (10, 11, 18).

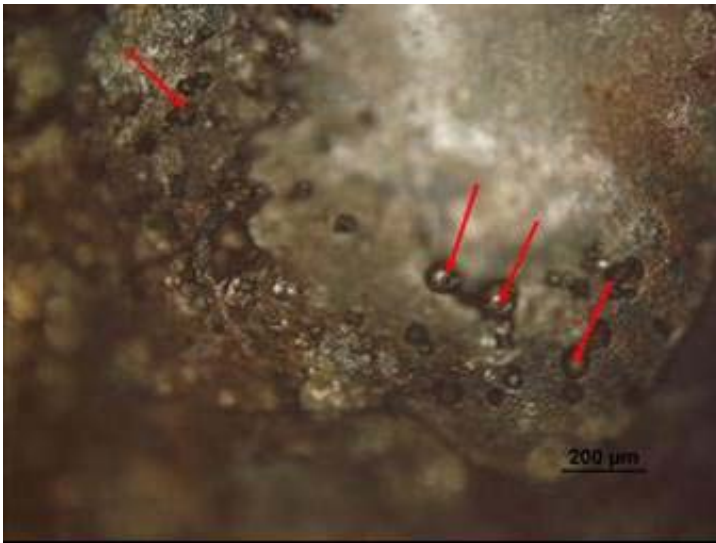
Figure 6 - Photograph of the filter. The attacked zone by pitting is indicated (10 X)
