## **Study of case to Internal Corrosion Monitoring using Non Intrusive and high resolution probes with Ultrasonic technology**

### ***Abstract***

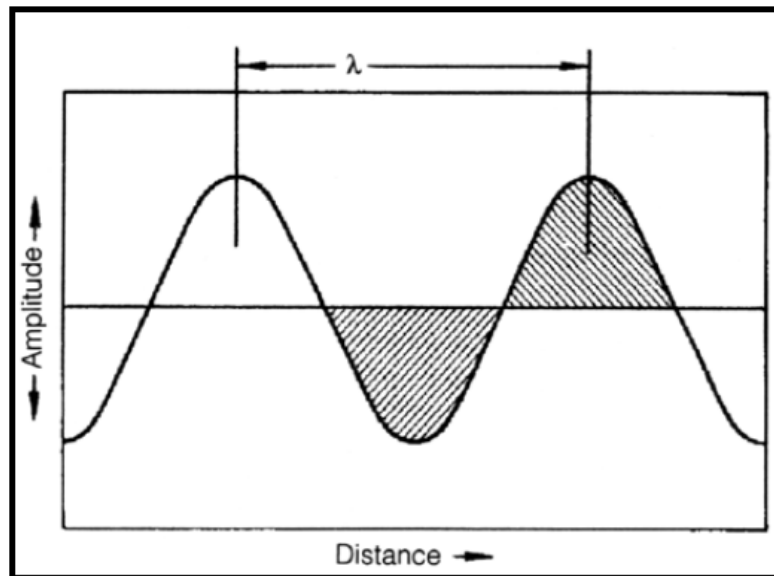
**Figure 1 - Wavelength Definition**

Wavelength is dependent on the speed of sound propagation through the material under test but remains constant in a given material. Since different materials propagate sound waves at different speeds, the wavelength in the different materials will vary. It is important to choose a transducer frequency that is best suited for the material under test. Wavelength (as depicted in Figure 1), can be determined by the formula:

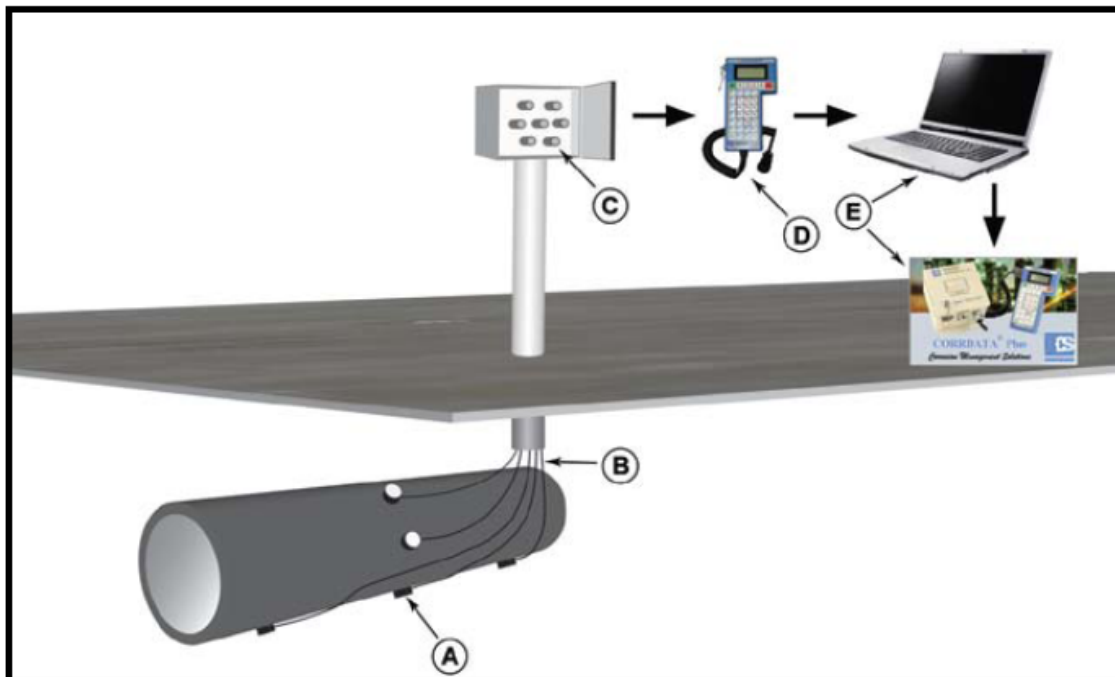
**Figure 2 - System Overview**

- A) Transducer
- B) Signal Cabling
- C) Reading Point
- D) Handheld Instrument
- E) PC Running Corrosion Management Software

Figure 2 shows the system diagram and it features:

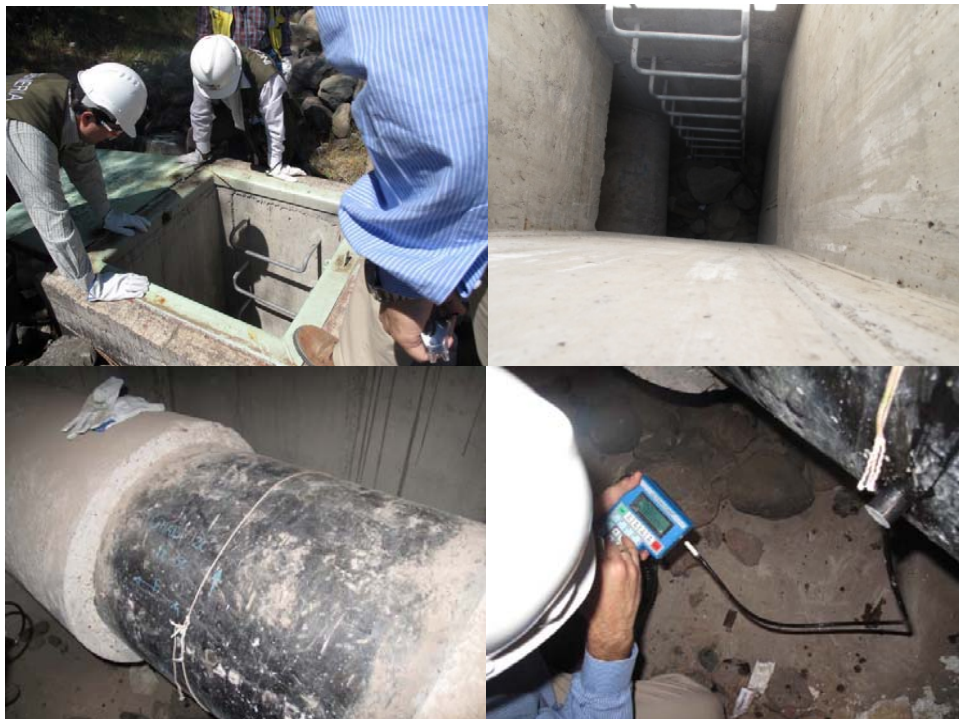
**Figure 3 - buried enclosure for an existent pipeline**

In regarding to internal corrosion/erosion monitor, the project considered to use the most common philosophy used in this industry at that moment in Chile, which is build a buried enclosure with a surface access in order to take measurements with portable ultrasonic equipments. Along over the pipeline were considered 54 locations with buried enclosures with 6 corrosion monitoring points per pipeline. These enclosures were estimated in US\$ 3,700,000.00. Additionally to the highest cost, these buried enclosures represented a risk for the person or worker such as flood of the enclosures, tumbles, poisoned animals inside, waste of time trying to open old cover or lock or it is blocked, along with others natural risk. With these buried enclosures, an operator must to go inside and down to carry out the measurements. Figure 3, below, are showing current buried enclosure for an existent pipeline in the same site.

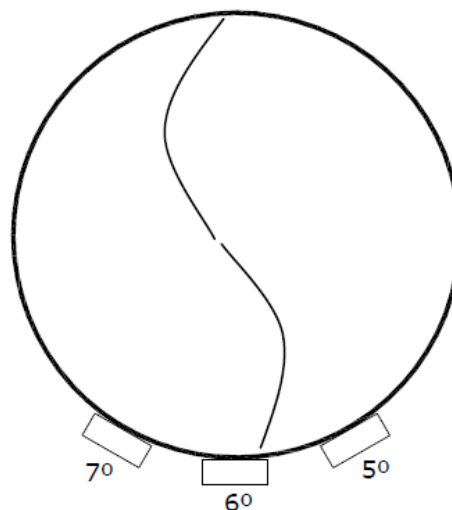
**Figure 4 – Position for install 03 sensors**

A new ultrasonic technology with permanent sensor and temperature compensation were installed instead to use traditional ultrasonic equipment and buried enclosure or digging up pipelines. Since the corrosive phase or erosion action in the system is in the bottom quadrant of the line, a sensors was installed at 6 o'clock position with two additional sensors offset by 15° and 30° either side; these two sensors should be located such that they are just below the position adjacent to the average liquid / gas interface, tailings concentration, since this is often the region of most intense corrosion or erosion. (Figure 4). These three transducers (probe) of 2,54 mm (1 inch) diameter by 2,54 mm (1 inch) high were permanently mounted to the monitoring point on each location.

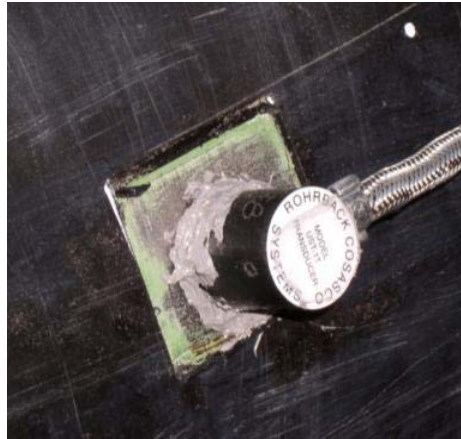
**Figure 5 – Sensor installed**

Transducers are to be installed on the bare pipe (Figure 5). So, paint and coating must to be removed in order to install the sensor. This is accomplished using a special adhesive or epoxy which also acts as an ultrasonic couplant. The transducer has a magnetic base to aid in holding it in position while the adhesive cures.

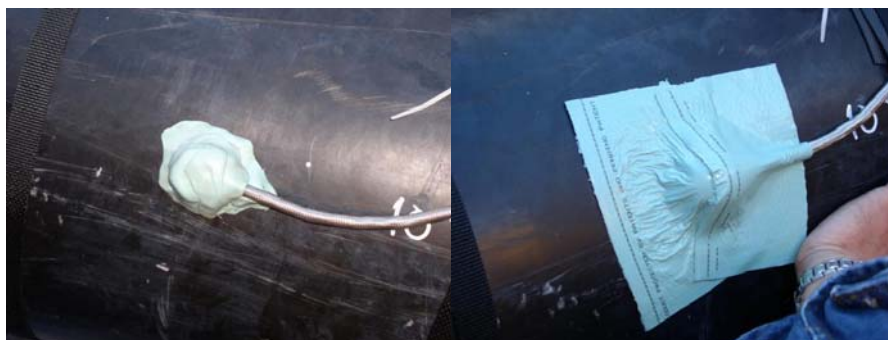
**Figure 6 – With repairing kit**

The pipe line was now ready for repair. Pipeline repair kit was used on pipe which is well suited for the ultrasonic transducers. This kit is a proven way of repairing pipe and preventing corrosion after the ultrasonic transducer installation. This repair kit is considered a visco-elastic fluid, which means it feels like a solid or rubber, but still has the characteristics of a fluid. These fluid properties allow the material to adhere to the pipe remarkably while providing resistance against cathodic disbonding and giving excellent corrosion protection.

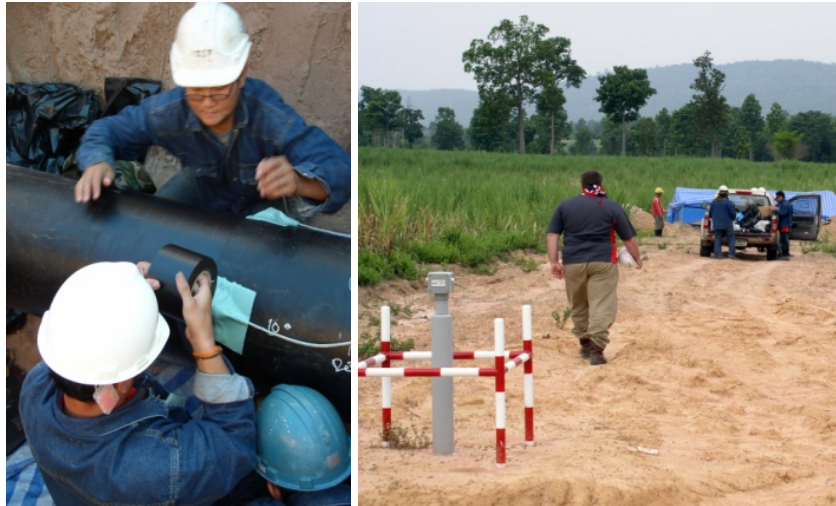
**Figure 7 – Finishing the installation**

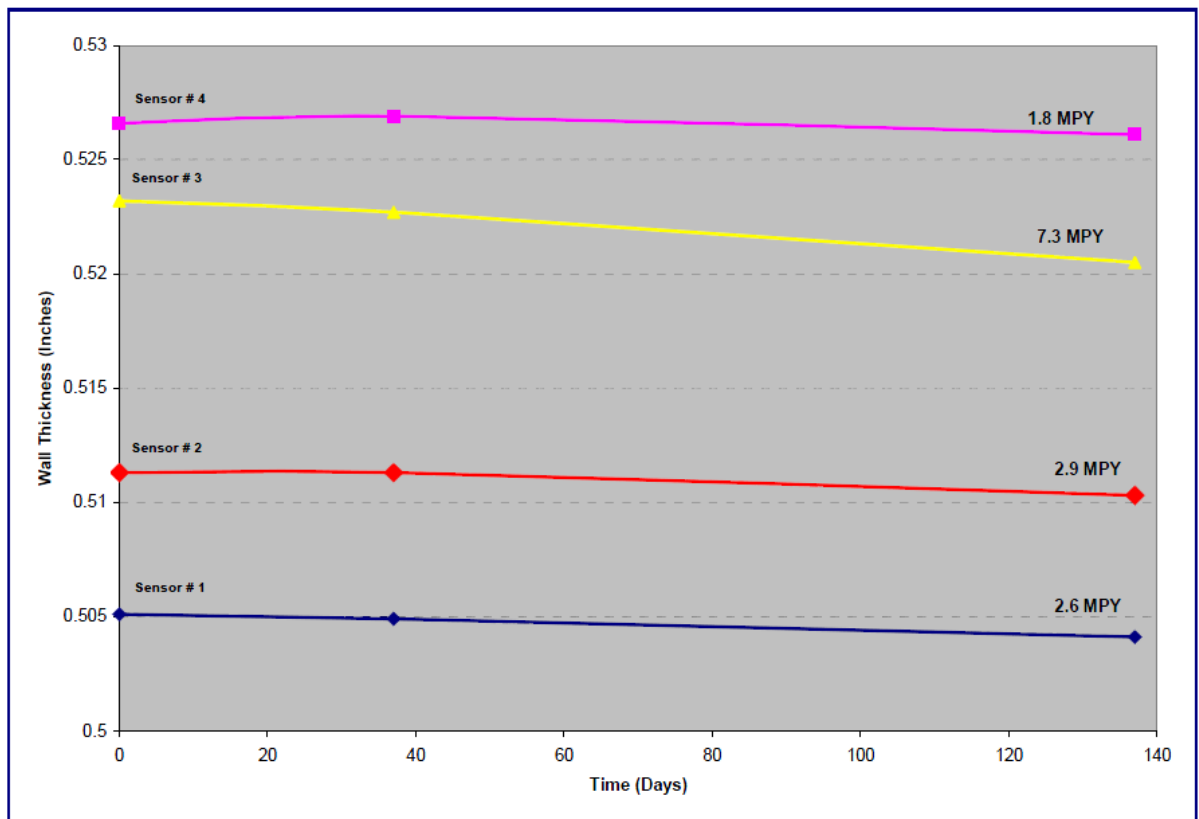
**Figure 8 – Gráfico comparing the sensors measurement at time**

The first example concerns a relatively short monitoring period of above ground, slightly sour, gas lines, at a facility operated by BP in Indonesia. Four ultrasonic new technology sensors arrayed on 30° centers in the bottom quadrant of the line were monitored for period of approximately 140 days; the resultant data is shown below. Despite short duration, this data illustrates the much enhanced measurement resolution of these new ultrasonic sensors, over conventional ultrasonic sensors. In this application it was possible to accurately measure a corrosion rate of 1.8 mpy in less than 140 days.

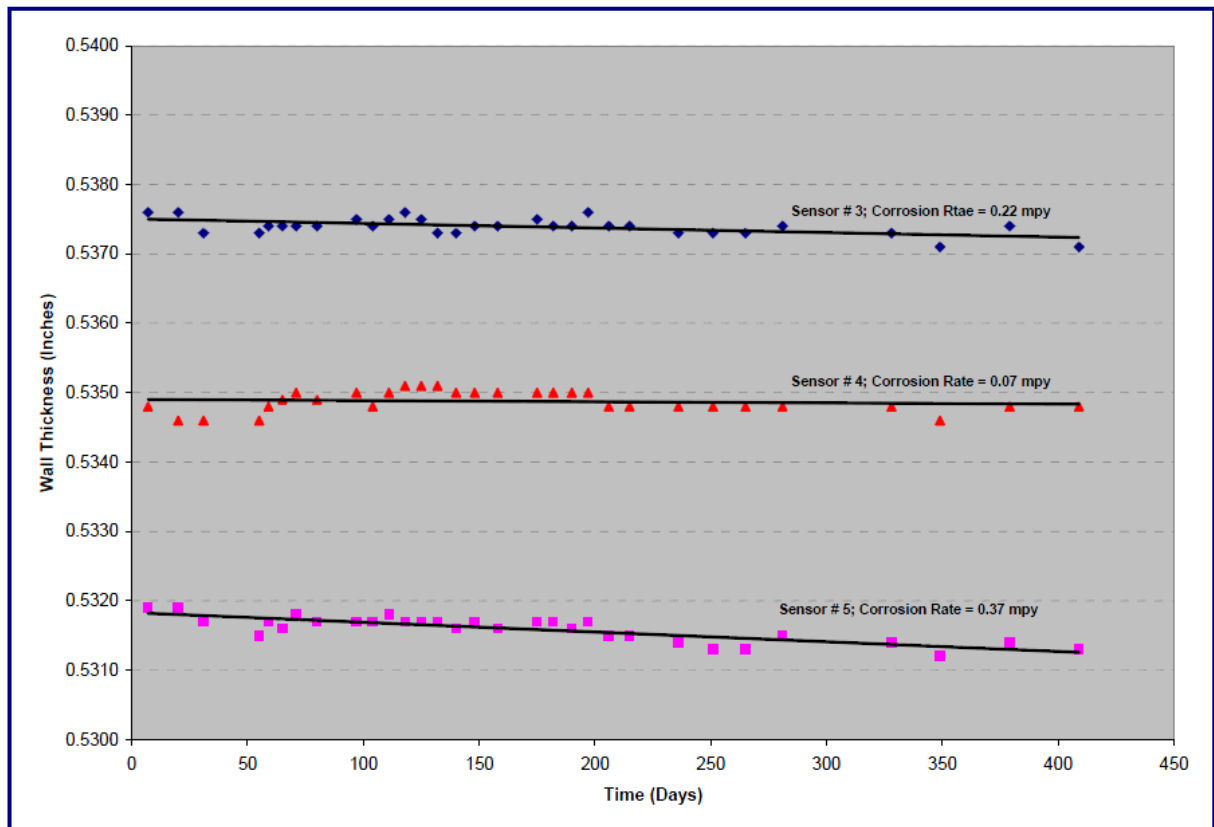
**Figure 9 – Gráfico comparing the sensors measurement at time**

The second example concerns multiple sensors installed on buried, sweet gas distribution lines, operated by Panhandle Easter at a gas storage salt dome in Minnesota, USA. The installation point was downstream of salt dome, and water knockout drum, at which point the gas nominally dry and, supposedly, minimally corrosive. The purpose of the installation was to ensure the efficiency of removal of salt water from gas, in the water knockout drum. The monitoring exercise has been in progress for 140 days, and is ongoing. The data from this installation is shown below. Clearly, the water knockout drum is successfully removing salt water, and the gas in the distribution line is minimally corrosive. From the point view of new sensors technique, the data again demonstrates the enhanced resolution capabilities, in that corrosion rates of less 0.00254 mm per year (0.1 mpy) are accurately measured in approximately 400 days, which is considerably better than even the theoretical resolution would predict. Further, the data indicates the extended longevity of the sensors.
