Trabalho apresentado durante o INTERCORR 2016, em Búzios/RJ no mês de maio de 2016.

## **The influence of microstructure and heat treatment of API X52 carbon steel on hydrogen diffusion**

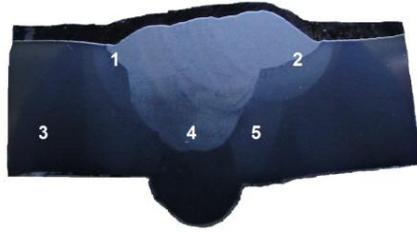
**Figure 1 - Photo of the weld zone of the API X52 carbon steel, with the positions that images were taken.**

The figure 1 is a scheme that indicates the positions where analyzes were performed with OM in the Base metal (BM), weld metal (WM). Base metal (Figure 2) has a heterogeneous distribution of ferrite and pearlite grains with grain boundaries well-defined. The same microstructure for the X52 steel was found in several other literatures [17, 18], possessing a ferritic-pearlitic combination.

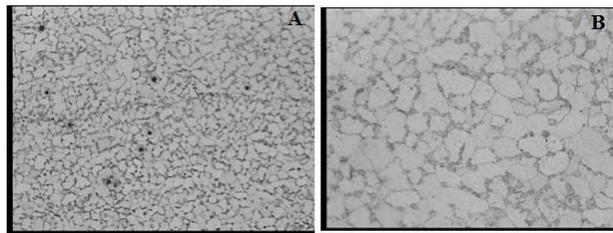
**Figure 2 - Position 3: Base Metal, image (A) zoom 200x and (B) 500x.**

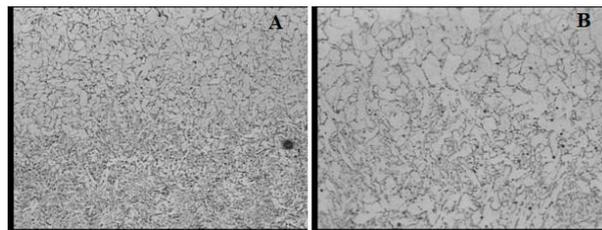
The welded joint (weld metal, figure 3) presents a microstructure formed by low recrystallization, where it is possible to observe pearlitic microstructure and a decrease in the grain boundaries with degenerated pearlite regions. This fact was discussed by Park [2] and can be explained because the structure of degenerated pearlite phases, without the banding pattern, was different from pearlite evolved by normalizing and slow cooling treatment. The cooling rate in the weld metal was higher than necessary to form of typical pearlite, and thus the carbon diffusion during cooling was not sufficient to form the lamellar structure of cementite. This microstructural arrangement will be discussed later as one of the factors that influenced the results obtained for the permeation tests.

**Figure 3 - Position 4: Weld metal, image (A) zoom 200x (B) 500x.**

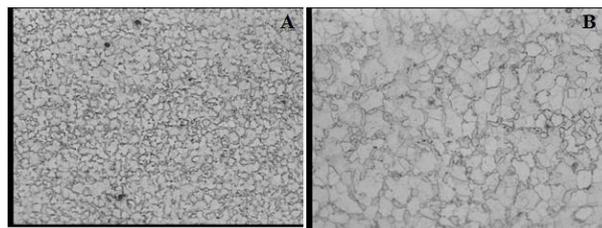
The figure 4 shows the Heat-Affected Zone (HAZ), where there is a great similarity with the microstructure of the BM; the little difference is due to the thermal effect caused by the deposition of the weld bead, which ultimately provides a grain growth microstructure of HAZ.

**Figure 4 - Position 5: Heat-Affected Zone, image (A) zoom 200x (B) 500x.**

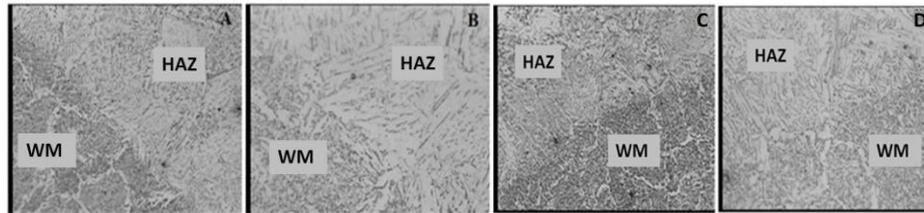
The figure 5 presents the interface between WM and HAZ, presenting the difference between the microstructures. It is possible to observe that the HAZ presents major pearlite grains, showing the effect of heat treatment caused during the welding process. According to other authors [19], The HAZ generated by the welding thermal cycle showed a complex recrystallized microstructure located near the fusion line, formed by coarse-grained ferrite, acicular ferrite, small discontinuous pearlite colonies and some bainite grains.

**Figure 5 - Positions 1 at the fig. 1: Interface weld metal and heat-affected zone, image (A) zoom 200x (B) 500x. Position 2 at the fig. 1: Interface weld metal and heat-affected zone, image (C) zoom 200x (D) 500x.**

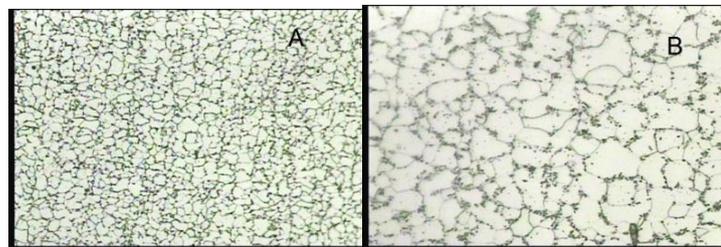
The figures 6 and 7 show the microstructure after the heat treatment, being annealed base metal (ABM) and quenched base metal (QBM), respectively. It is possible to note the difference between the microstructure obtained. It is able to observe the presence of the pearlitic structure in the figure 6 (ABM); while the presence of martensite is noted in the quenched base metal - QBM (Figure 7).

**Figure 6 - API X52, annealed base metal, zoom (A) 200x (B) 500x**

The highest hydrogen flux occurred in the ABM samples as proved in figure 21 and table 8. Annealed samples showed the micrographs (Figure 6 and 15) considerable grain growth of ferrite and pearlite formation at the edges. Consequently, this microstructure with large difference atomic arrangement of its unit cells was the condition that caused the increase of the hydrogen flow through the material. The annealed microstructure presented on figures 6 and 15, had lower discordances density than others samples. Therefore, according to Ayesha [16] ferrite grains exhibited the highest diffusivity in samples. In addition, Svoboda [28] confirmed that the annealing thermal treatment was probably sufficient to recover the majority of defects, decreasing the discordance density and only a small amount of them survived. Therefore, the hydrogen atom found less difficulty to pass through the metal. This fact was also confirmed by other authors [6].

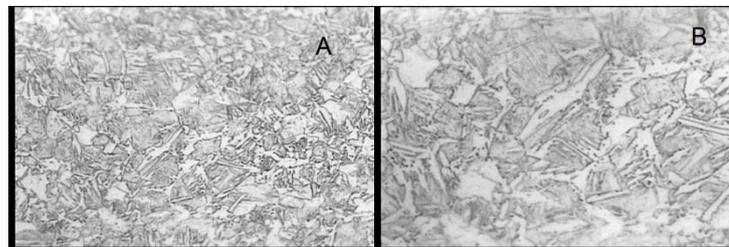
**Figure 7 - API X52, quenched base metal, zoom (A) 200x (B) 500x.**

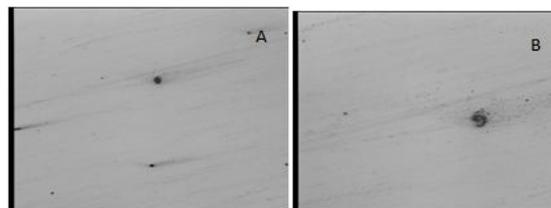
Observations of the materials, without chemical attack, revealed the presence of a significant amount of inclusions, as shown on the figures 8 and 9.

**Figure 8 – Base Metal without chemical attack, image (A) zoom 200x and (B) 500x.**

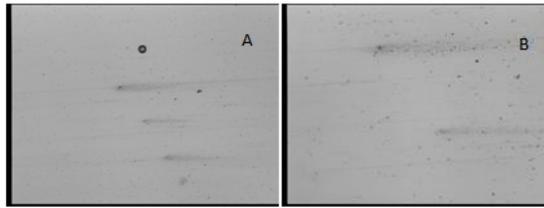
**Figure 9 – Weld Metal without chemical attack, image (A) and zoom 200x and (B) 500x.**

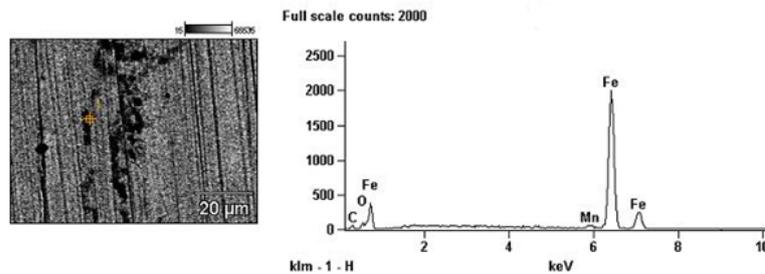
The EDS technique was used to evaluate the composition of these inclusions in order to verify the chemical elements present into the inclusions. The figures 10, 11 and 12 show these analyses. Therefore, the inclusions presented in API X52 carbon steel showed significant concentrations of S and Mn. Ayesha [16] has cited that MnS inclusions are considered strong irreversible trapping sites for hydrogen, working as follows: During the solidification of steel, Mn can combine with S giving rise MnS inclusions. The behavior of Inclusions/Matrix metal interface are reported in literature as strong trapping sites for hydrogen, consequently decreasing the hydrogen flux through the material.

**Figure 10 - Analysis by EDS of inclusions present in the API X52 carbon steel.**

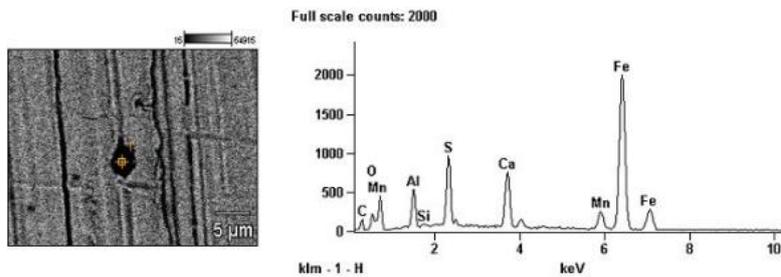
**Figure 11 - Analysis by EDS of inclusions present in the API X52 carbon steel.**

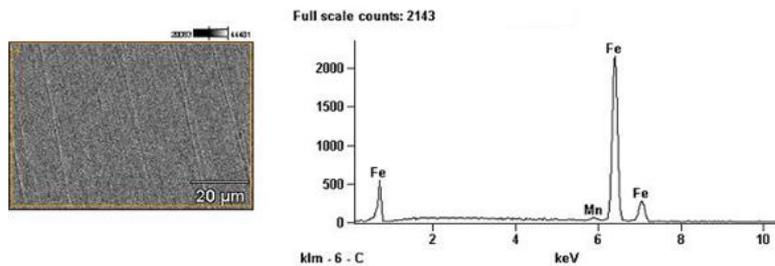
**Figure 12 - Analysis by EDS of area without inclusions in the API X52 carbon steel.**

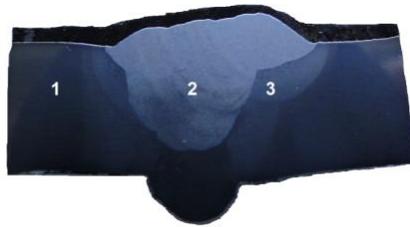
The scanning electron microscopy (SEM) were performed at three different positions at the samples, as shown at the figure 13. The BM (Figure14-1) presents predominate phases of ferrite and pearlite. The HAZ and WM (Figure 14-2 and14-3) presents micro constituents of Austenite/Martensite. Called micro constituent A/M or micro phase A/M, they are regions of microscopic dimensions presented in C-Mn steels and low alloy that consist of cells stabilized austenite. The frequent presence, and high levels of martensite in these "islands" of austenite, derives its name Austenite-Martensite [20]. Chatzidouros [17] emphasizes that most pipeline steels are manufactured using thermo-mechanical processes that involve multiple heating and rolling stages which favors the formation of M/A constituents in low carbon steels. This micro constituent directly affects the tenacity of material due to your high hardness and fragility, the high density of discordances in the sub microstructure contributes to this formation [21].

**Figure 13 - Photo of the weld metal API X52 carbon steel, with the positions of the captured images.**

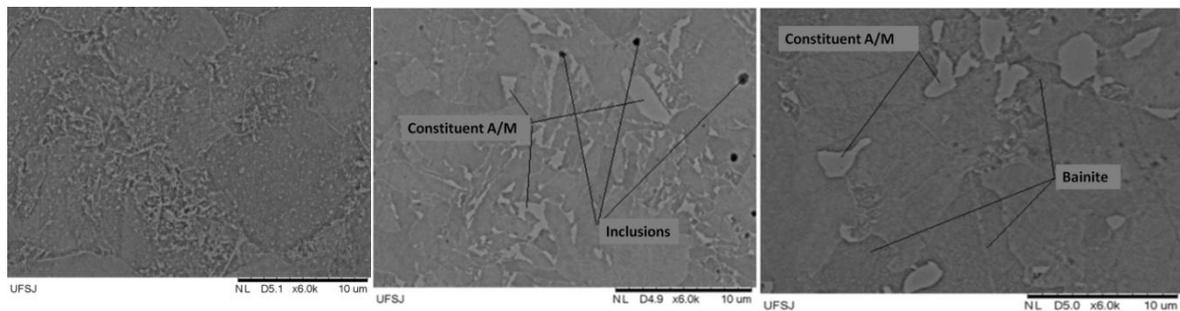
**Figure 14 - Position 1: Image of Base Metal zoom 5000x.. Position 2: Image of Weld Metal zoom 5000x, showing the constituent A / M and the inclusions. Position 3: Image of the heat-affected zone zoom 5000x, showing the constituent A / M and regions formed by bainite.**

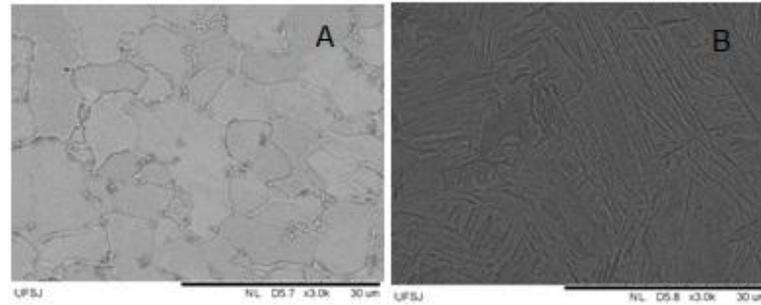
After heat treatments, the SEM analyzes show that the grains of pearlite were more defined and have a little increase in the samples of annealed base metal, as showed in the figure 15 (A). The quenched base metal specimens had presented martensitic structure, but due to the low carbon have noted some grain of ferrite, as proved in the figure 15 (B).

**Figure 15 - Image of Base Metal after two different heat treatments. Annealed (A), and quenched (B), zoom 3000x.**

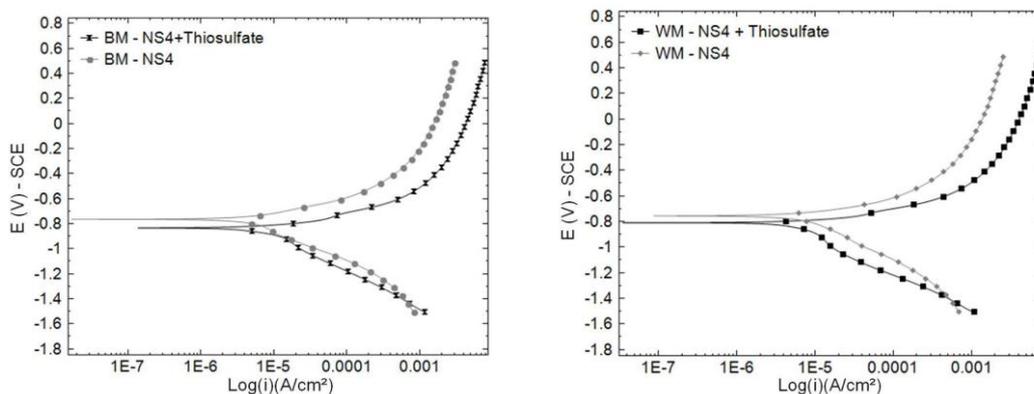
The cathodic and anodic polarization curves obtained in solutions NS4 and NS4 + thiosulfate with a concentration of 10-2M are shown in the figures 16 and 17. The anodic current density was highest for NS4 + thiosulfate solution, it may be attributed to reduction reaction of thiosulfate that converted into H<sub>2</sub>S [22]. Thus, the electrochemical tests for the specimens ABM and QBM were performed only in this solution, that was more aggressive (figure 17 and table 8).

**Figure 16 - Anodic and cathodic polarization curves of the base metal (BM) and weld metal (WM) of the API X52 carbon steel immersed in the NS4 synthetic soil solution and NS4 + thiosulfate modified  $10^{-2}M$ .**

Analyzing the Figures 16 and 17 can be seen that the corrosion potential ( $E_{corr}$ ) to NS4 + thiosulfate solution for all samples ranged around an average value of -0.758 mV. The current density in anodic polarization curves presented similar behavior. It is the conclusive proof that different microstructures have no significant effects about corrosion resistance, but the thiosulfate addition initially generates the reduction of corrosion potential in relation to the NS4 standard solution. It is possible to note that a significant variation of the current occurred when the thiosulfate was added, showed on table 7. It can be stated that the addition of thiosulfate accentuated the corrosion process, anodic current increase with respect to the solution without thiosulfate. It proves that the solutions with thiosulfate presented a corrosion potential more anodic, becoming more aggressive, which evidence the results obtained in the polarization curves.

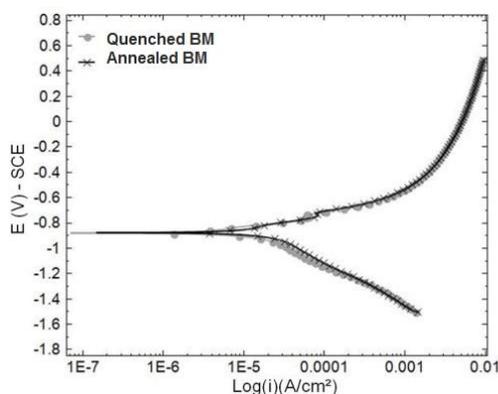
**Figure 17 - Anodic and cathodic polarization curves of the annealed base metal (ABM) and quenched base metal (QBM) of the API X52 carbon steel immersed in the NS4 + thiosulfate modified 10-2M solution.**

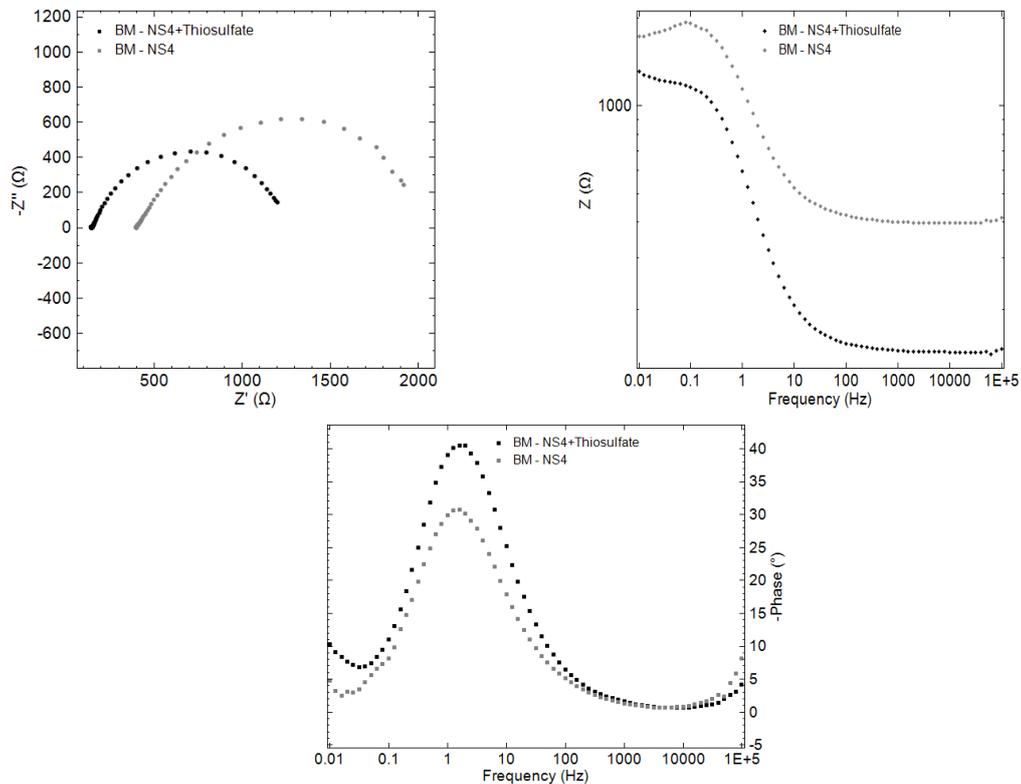
**Figure 18 - Nyquist diagrams (upper left), Bode module (upper right) and Bode phase angle (bottom) for the base metal of the API X52 carbon steel immersed in NS4 synthetic soil solution and modified solution of NS4 + thiosulfate 10-2M.**

The Nyquist diagram shows an increased capacitive arc when using the less aggressive solution (NS4) and Bode shows a large decreasing in impedance when using the solution NS4 + thiosulfate. On the diagram module Bode notes a significant decreasing in impedance at low frequencies when using the solution NS4 + thiosulfate. This might suggest a decreasing in corrosion resistance of steel in the presence of thiosulfate.

The results of EIA for base metal (BM) and weld metal (WM) in the NS4 synthetic soil solution and NS4 + thiosulfate with concentration of 10-2M are shown in the figures 18,19. The figure 20 presents the EIS for the annealed base metal (ABM) and quenched base metal (QBM) in NS4 + thiosulfate with concentration of 10-2M.

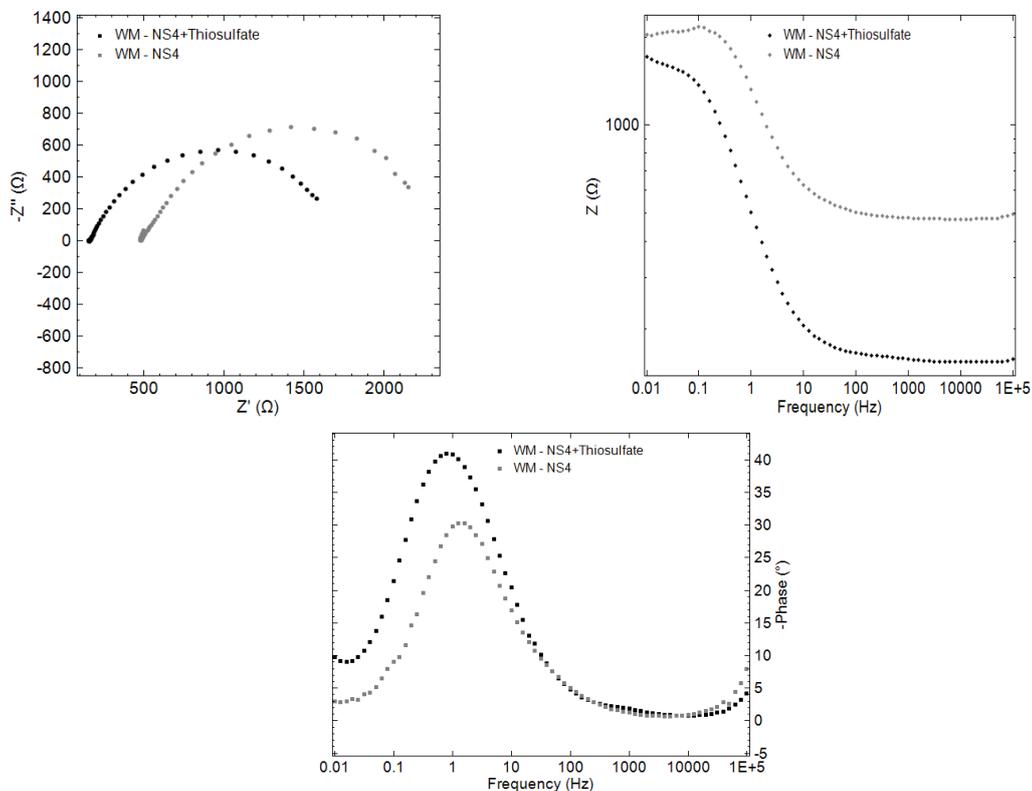
**Figure 19 - Nyquist diagrams (top left), Bode Module (top right) and Bode phase angle (bottom) to the weld metal of the API X52 carbon steel immersed in NS4 synthetic soil solution and modified solution of NS4 + thiosulfate 10-2M.**

The figure 19 shows the Nyquist diagrams indicates an increasing in capacitive arc, and Bode already indicates increasing impedance at low frequencies to NS4 solution, which would suggest an increase in corrosion resistance of steel in this solution. The Bode diagram phase angle reveals that the mechanisms for the steel in both solutions are similar. These results confirm those obtained in polarization curves and are similar to those for the BM. As previously evidenced the higher aggressivity of solution NS4+thiosulfate, samples heat treated were tested only in this solution and the figure 20 shows the results.

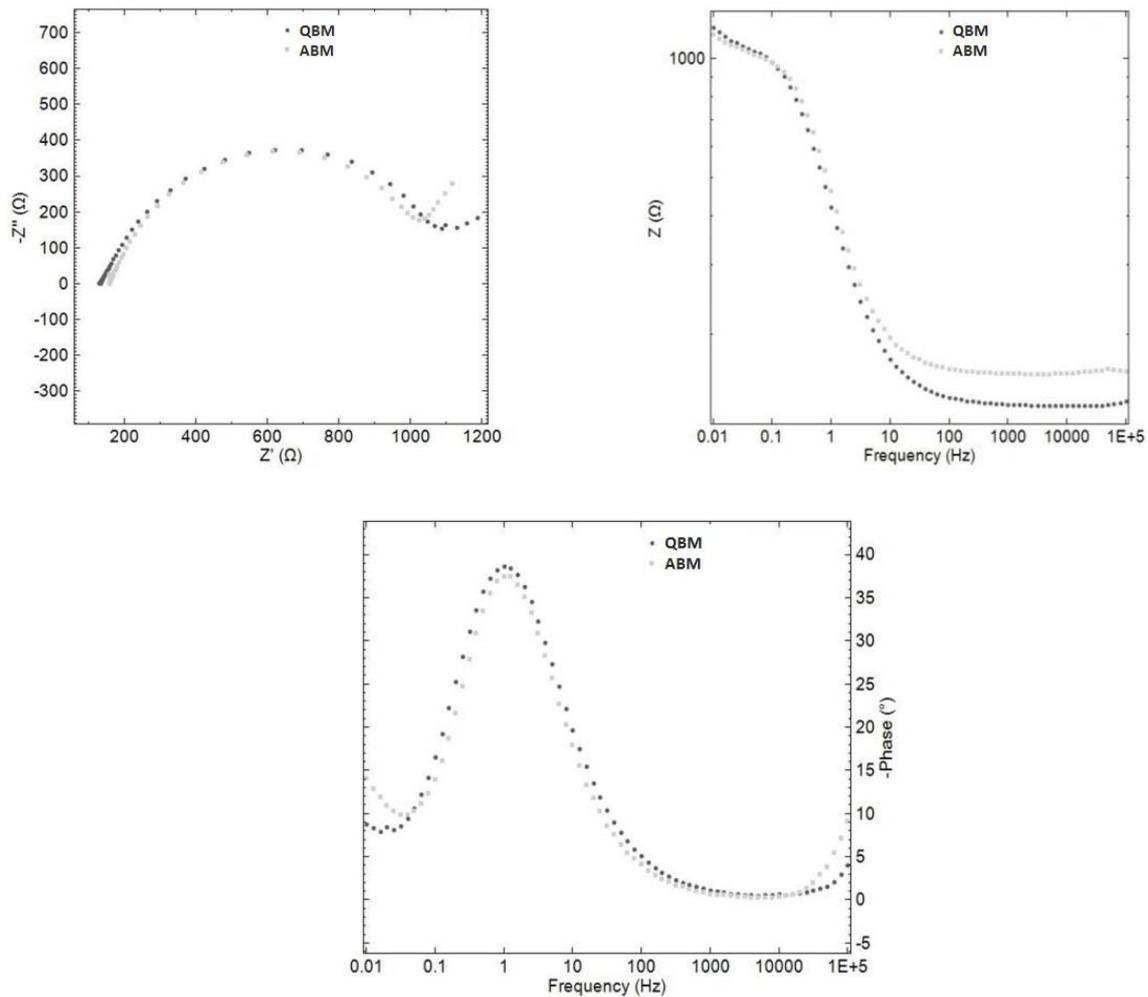
**Figure 20 - Nyquist diagrams (top left), Bode Module (top right) and Bode phase angle (bottom) to the annealed base metal (ABM) and quenched base metal (QBM) of the API X52 carbon steel immersed in modified solution of NS4 + thiosulfate 10-2M.**

Nyquist diagrams show that both samples, ABM and QBM, had the same behavior. The capacitive arcs are very similar showing the same impedance module from the lower frequencies up the highest. With the Bode module diagram can be observed practically the same impedance value at low frequencies, but in higher frequencies occurs a decrease in ABM impedance. The mechanism in Bode phase diagram is equal for both, showing the highest phase angles in the medium frequencies region. Through these data and observations it is clear that the heat treatments performed did not affect the corrosion resistance of the material.

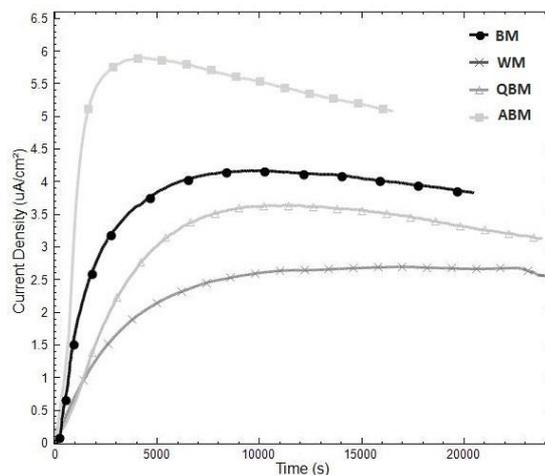
The figure 21 presents the test permeation of all specimens. Tests were performed by hydrogen permeation using the more aggressive solution, namely NS4 + thiosulfate, already evidenced in polarization and electrochemical impedance tests. The permeation tests with cathodic potential applied of -1.5 V below  $E_{corr}$  were carried out in order to simulate cathodic protection system, once ISO 15589-1 [13] describes that from values lower than -1.2V the steel already suffering effects of hydrogen embrittlement.

**Figure 21- Hydrogen Permeation, base metal (BM), weld metal (WM), annealed base metal (ABM) and quenched base metal (QBM) of API X52 carbon steel in the modified solution NS4 + thiosulfate 10-2 M.**

The tests conducted on the QBM that are possible to see in the figure 21 and in the table 9, had lower current flow and enhance the time to reach a stationary value to permeation than the ABM and BM. Similar results were obtained for Nagu [25], the quenched material had martensitic inter-lath interfaces, high density of dislocations and carbide–matrix interfaces all of which act as hydrogen traps. These traps were apparently effective in delaying hydrogen transport as those in the as-received steel. This behavior is probably due to the difference in grain size caused by thermal treatments performed and generated several changes in the structure of the material. The fastest cooling rate during heat treatment process promotes the transformation to martensite at lower temperature with an increase in dislocation density, arising from the transformation volume change.

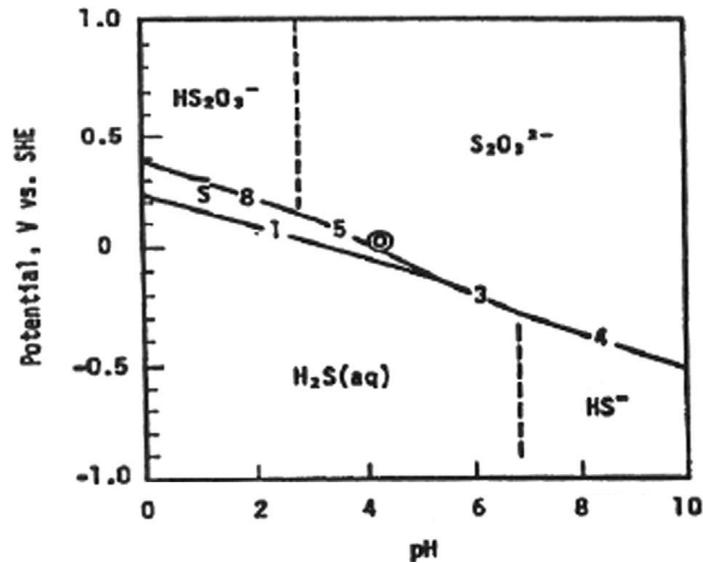
The solution NS4 + thiosulfate was able to induce absorption and permeation of hydrogen in all materials tested. The reduction process converts thiosulfate to H<sub>2</sub>S [14]. In that case, the effect of H<sub>2</sub>S does not allow H<sub>0</sub> turns into H<sub>2</sub>. Due to the addition of thiosulfate, the potential of the cathode side in contact with the steel were located within the domain of stability of H<sub>2</sub>S (Figure 22). Therefore, there is an increase in the activity of ions and reduction hydrogen on the steel surface [15]. As found in the literature, there are different factors that involve the flow of hydrogen through the material as well as cited below.

Figure 22 - E vs. pH for thiosulfate and H<sub>2</sub>S thermodynamic equilibrium in aqueous solutions [11].
