Trabalho apresentado durante o INTERCORR 2018, em São Paulo, no mês de maio de 2018.

Effect of the anodizing potential on the corrosion behavior of the AZ31B magnesium alloy

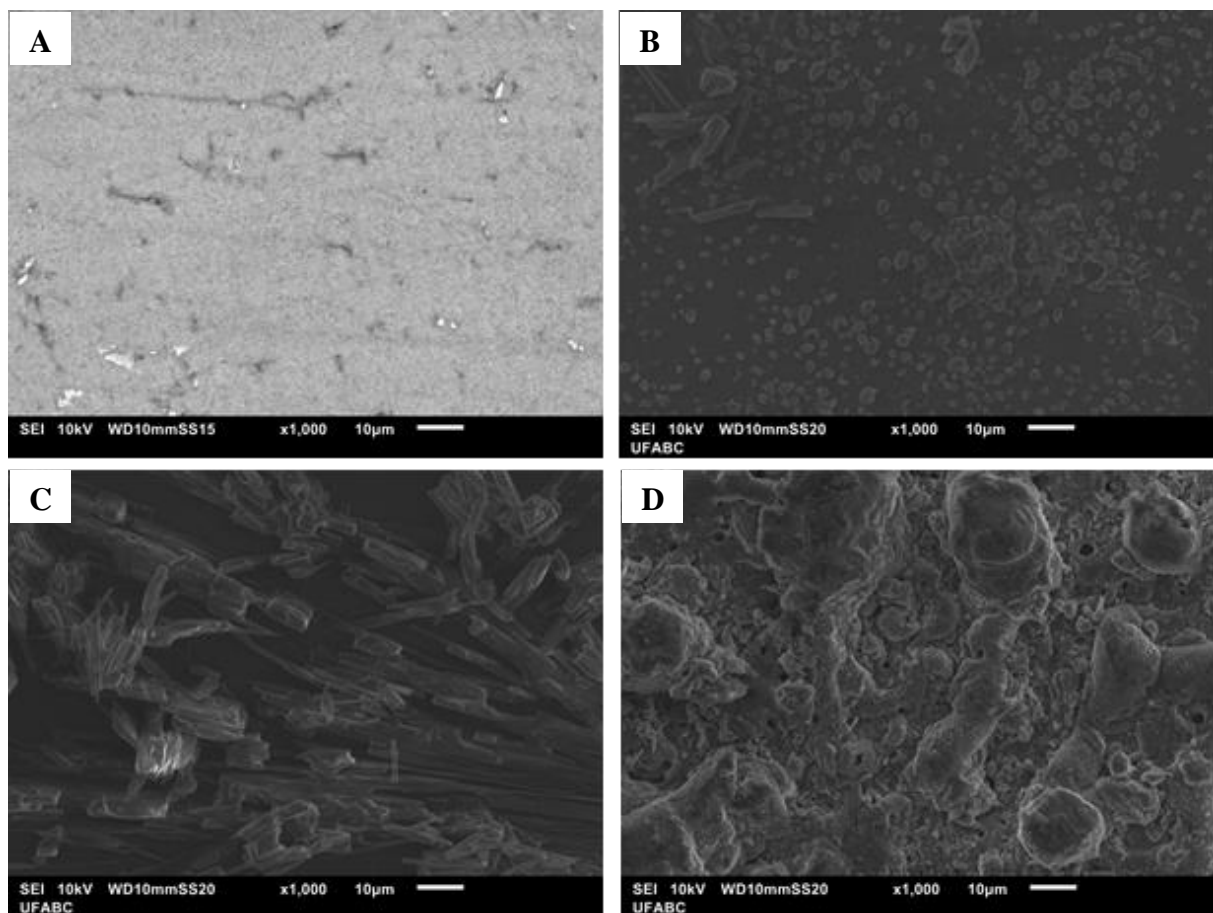
SEM images of the AZ31B magnesium alloy in the as-polished and anodized conditions are shown in Fig. 1. The bare substrate (Fig. 1a) showed some cracks on its surface. The film formed under 20 V (Fig.1b) produced a non-uniform and defective distribution of the film along the substrate. The same features can be observed for the 60 V condition, in which the film did not spread over the whole surface, although its particle size and coverage were higher than those of the 20 V-film. The film formed at 120 V covered the whole substrate and is denser and thicker than the others. However, this condition promoted some holes of different sizes caused by sintering (12,13). Furthermore, although high anodizing voltages are capable of increasing the film thickness, they also creates pores and micro-cracks as well (14-16).

Figure 1 – SEM micrographs of the AZ31B alloy in the as-polished and anodized conditions: A) As-polished; B) 20 V; C) 60 V and D) 120 V.

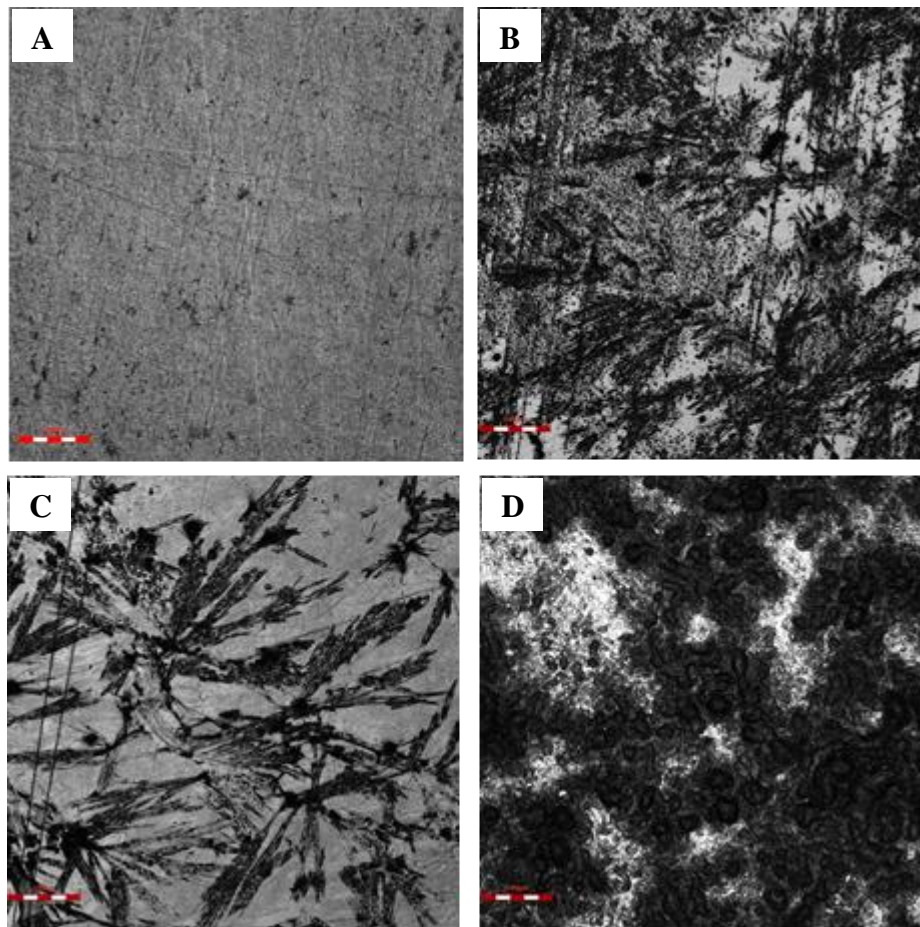
CLSM images of the AZ31B magnesium alloy in the as-polished and anodized conditions are shown in Fig. 2. In Tab. 1, roughness average values (Ra) of each condition are presented. As can be perceived from the images, all the coating conditions exhibited a heterogeneous surface. The anodized layers obtained at 20 and 60 V are porous and it did not cover the whole surface. In turn, the 120 V-film is more homogeneously distributed. From the results

shown in Tab. 1, the Ra values increases with the anodizing potential in agreement with the literature (17, 18).

Figure 2 – CSLM images of the AZ31B alloy with and without anodized films A) As polished; B) 20 V; C) 60 V and D) 120 V.

Table 1 – Roughness average parameter of the AZ31B alloy samples determined from the CLSM micrographs shown in Fig. 2.

Conditions	Roughness average (Ra)
As-polished	0.07 ± 0.01
20 V	0.28 ± 0.05
60 V	1.35 ± 0.24
120 V	1.39 ± 0.18

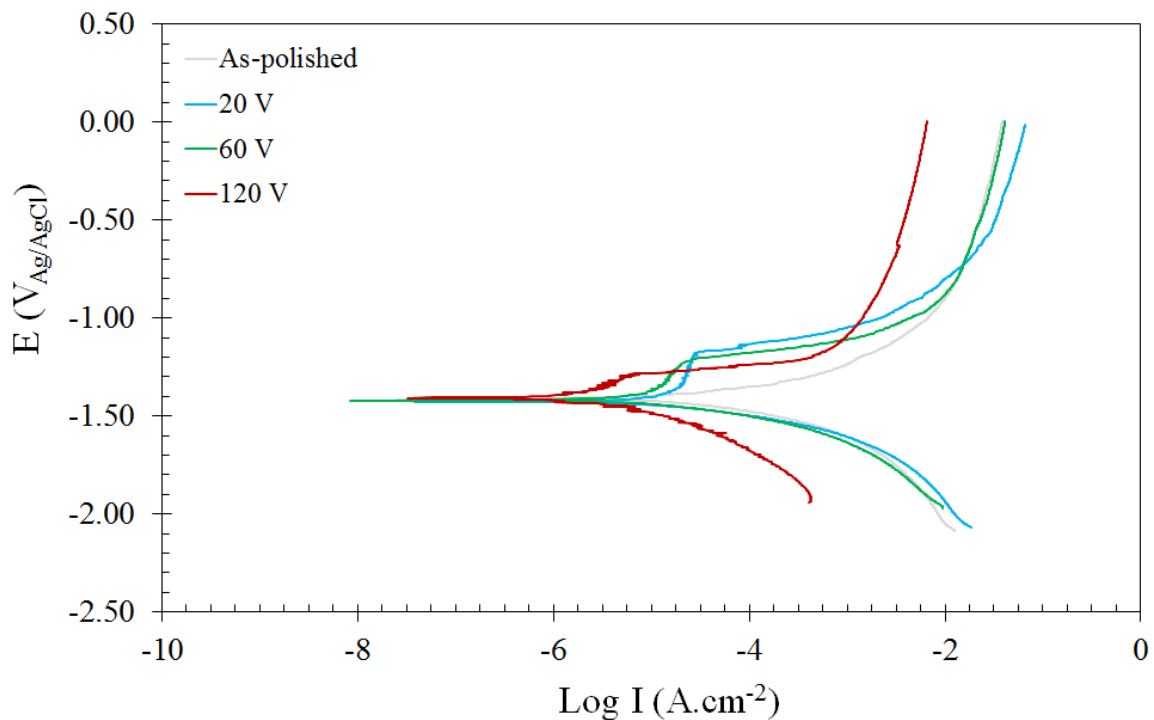
Potentiodynamic polarization curves of the AZ31B magnesium alloy in the as-polished and anodized conditions are shown in Fig. 3. The values of corrosion potential (E_{corr}) and corrosion current density (I_{corr}) were determined from the curves using the Tafel extrapolation method, considering only the cathodic branches. The results are displayed in Tab. 2. As can be observed in Fig. 3, the E_{corr} values were not substantially affected by the presence of the anodized films; it indicates that the electrochemical stability of the system was not modified. However, the corrosion current density, in turn, was strongly affected by the anodized layers, especially for the 120 V condition for which i_{corr} is reduced by almost one order of magnitude

with respect to the as-polished material. This parameter denotes the capability of the substrate to withstand anodic dissolution. According to Chai et al. (2008), the electric parameters of the anodizing process such as voltage and current density have marked effect on the film thickness and morphology. At higher potentials is expected to obtain thicker anodized layers, meanwhile it promotes an increase in the roughness and porosity of the film, which is in agreement with the literature (18,19). An incipient passive region is perceived in the anodic branch of the polarization curves for the anodized samples, while the bare substrate presents an active dissolution. This behavior suggests that the anodizing treatment produces a protective coating in the AZ31B magnesium alloy.

Figure 3 – Potentiodynamic polarization curves of the AZ31B alloy in the as-polished and anodized conditions in PBS electrolyte at room temperature.

Table 1 – Electrochemical parameters of the AZ31B alloy samples determined from the potentiodynamic polarization curves shown in Fig. 3

Conditions	E_{corr} ($V_{\text{Ag/AgCl}}$)	I_{corr} ($\mu\text{A}\cdot\text{cm}^{-2}$)
As-polished	-1.410	34.1
20 V	-1.428	25.4
60 V	-1.420	13.1
120 V	-1.409	3.5
